A/C Type : N/A  
 A/C Registration : N/A  
 Reason for BSI : Assessment

Model : JT15D-5  
 A/C MSN : N/A  
 ESN: PCE-JA0148  
 TSN:3062:45

VIDEO BOROSCOPE INSPECTION OF ENGINE JT15-D REPORT

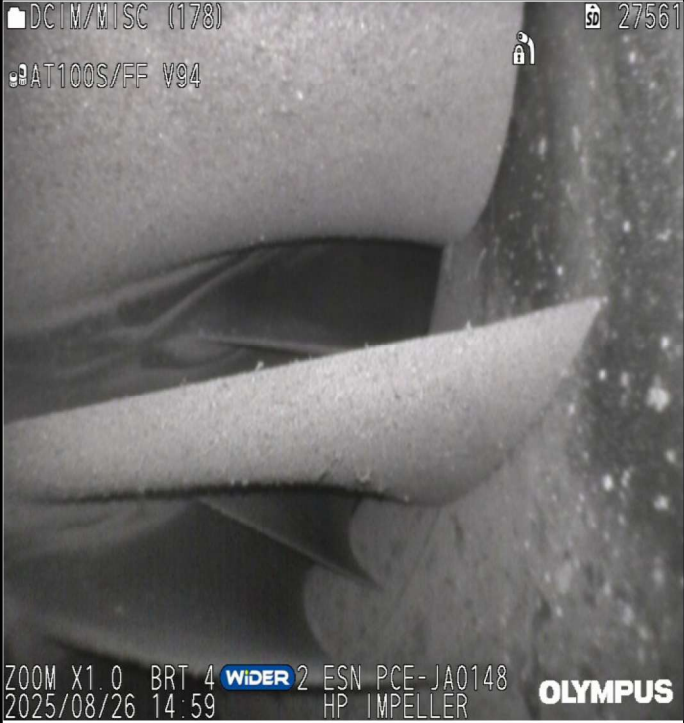
REF AMM 72-00-00	HP IMPELLER
<p><b>CONDITION:</b></p> <p>Contamintion observed with heavy enviromantal deposit.Nil significant findings.</p>

<p><b>DISPOSITION:</b></p> <p>Acceptable as per AMM.                  Serviceable as is.</p>	
REF AMM 72-00-00	COMBUSTION CHAMBER
<p><b>CONDITION:</b></p> <p>Contamintion observed with heavy enviromantal deposit.Nil significant findings.</p>

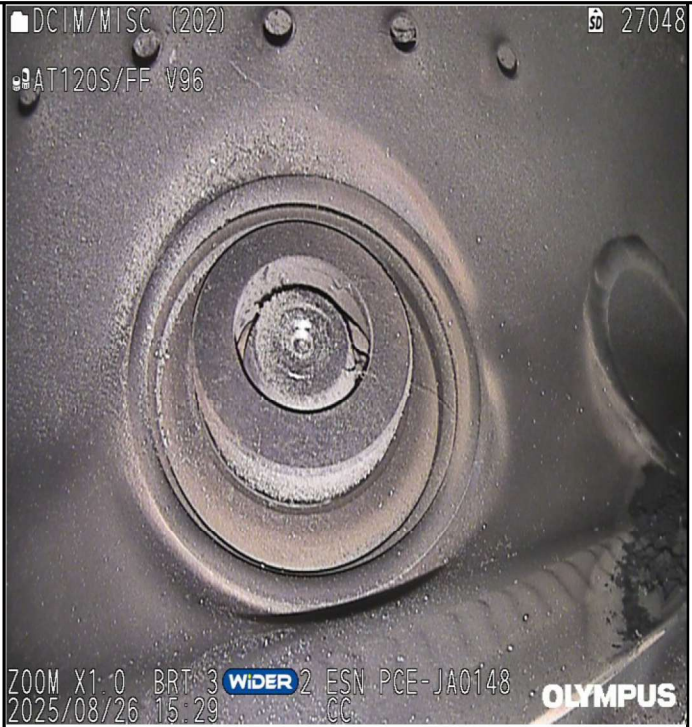
REF AMM 72-00-00	FUEL NOZZLES
<p><b>CONDITION:</b>            Contamintion observed with heavy enviromantal deposit.Nil significant findings.</p>

<p><b>DISPOSITION:</b>            Acceptable as per AMM.            Serviceable as is.</p>	
REF AMM 72-00-00	LARGE EXIT DUCT
<p><b>CONDITION:</b>            Contamintion observed with heavy enviromantal deposit.Nil significant findings.</p>

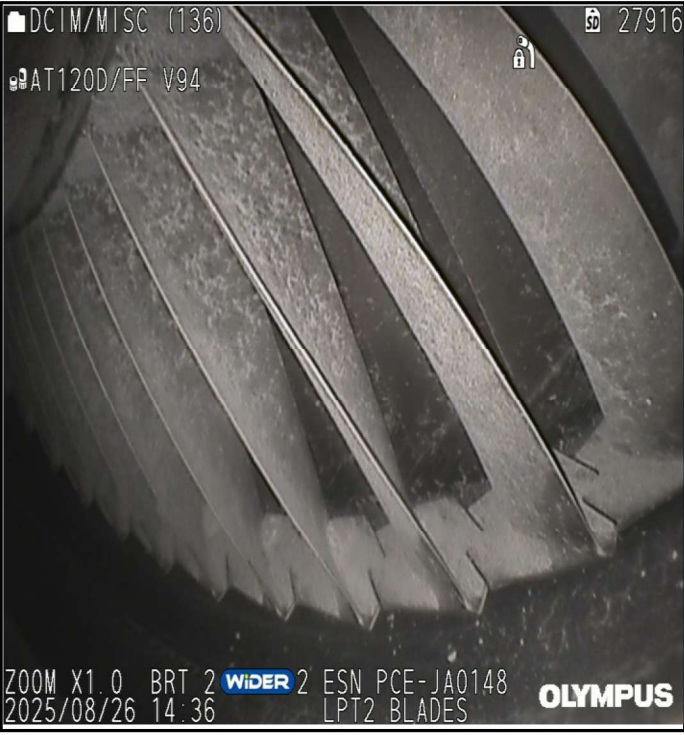
REF AMM 72-00-00	LPT STAGE 2 BLADES
<p><b>CONDITION:</b> Contamination observed with heavy environmental deposit. Nil significant findings.</p>

<p>DCIM/MISC (136) 27916 AT120D/FF V94 ZOOM X1.0 BRT 2 WIDER 2 ESN PCE-JA0148 2025/08/26 14:36 LPT2 BLADES OLYMPUS</p>
<p><b>DISPOSITION:</b> Acceptable as per AMM. Serviceable as is.</p>

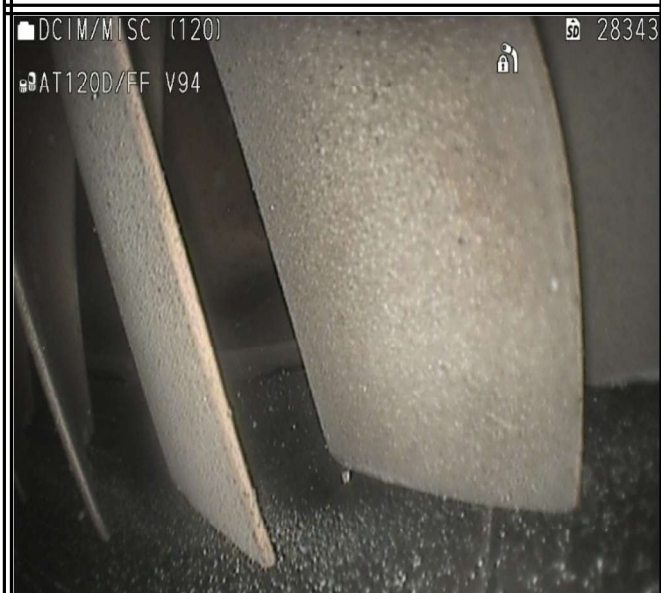
REF AMM 72-00-00	SMALL EXIT DUCT
<p><b>CONDITION:</b> Contamintion observed with heavy enviromantal deposit.Nil significant findings.</p>	
<p><b>DISPOSITION:</b> Acceptable as per AMM. Serviceable as is.</p>	
REF AMM 72-00-00	HPT BLADES
<p><b>CONDITION:</b> Contamintion observed with heavy enviromantal deposit.Nil significant findings.</p>	
<p><b>DISPOSITION:</b> Acceptable as per AMM. Serviceable as is.</p>

<p>ZOOM X1.0 BRT 3 WIDER 2 ESN PCE-JA0148 2025/08/26 14:24 HPT BLADES OLYMPUS</p>	<p>DCIM/MISC (144) 27870</p> <p>AT120D/FF V94</p>

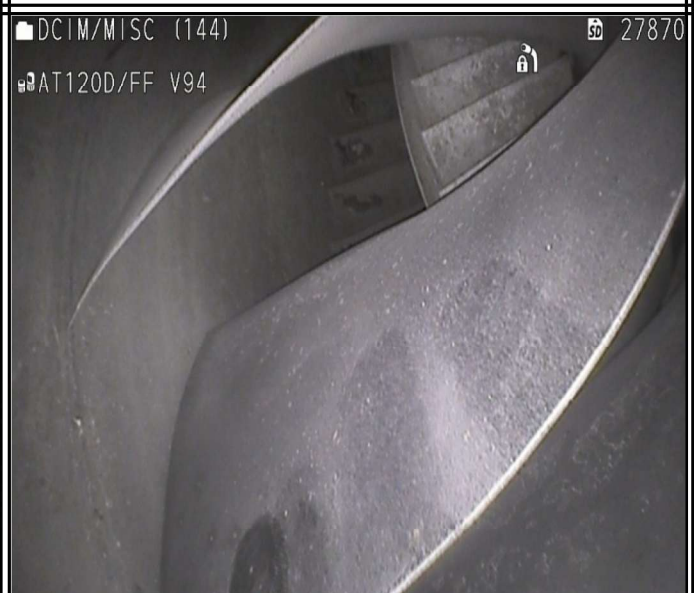
REF AMM 72-00-00	LP BOOSTER BLADES
<p><b>CONDITION:</b>                  Contamintion observed with heavy enviromantal deposit.Nil significant findings.</p>	 
<p><b>DISPOSITION:</b>                  Acceptable as per AMM.                  Serviceable as is.</p>	
REF AMM 72-00-00	LP STATOR VANES
<p><b>CONDITION:</b>                  Contamintion observed with heavy enviromantal deposit.Nil significant findings.</p>	 
<p><b>DISPOSITION:</b>                  Acceptable as per AMM.                  Serviceable as is.</p>

<p>ZOOM X1.0 BRT 2 WIDER 2 ESN PCE-JA0148 2025/08/26 14:41 BOOSTER BLADES OLYMPUS</p>
<p>DCIM/MISC (148) 27815</p> <p>AT120D/FF V94</p>

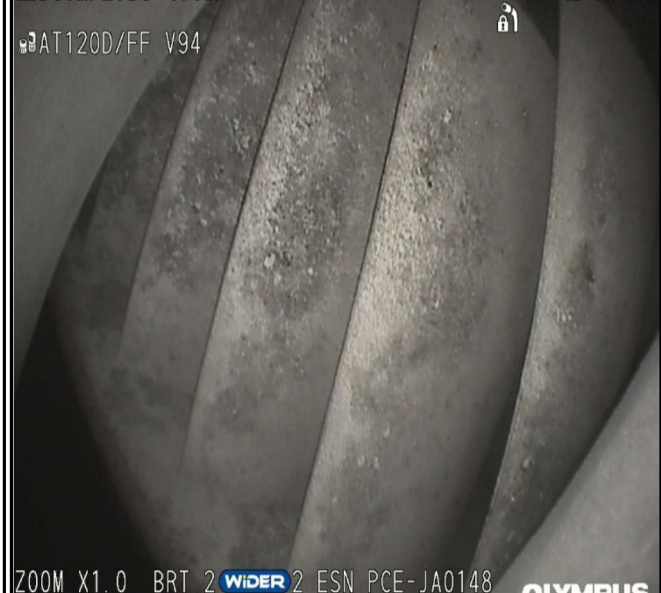
<p>ZOOM X1.0 BRT 2 WIDER 2 ESN PCE-JA0148 2025/08/26 14:43 LP STR VANES OLYMPUS</p>	<p>DCIM/MISC (128) 28109</p> <p>AT120D/FF V94</p>

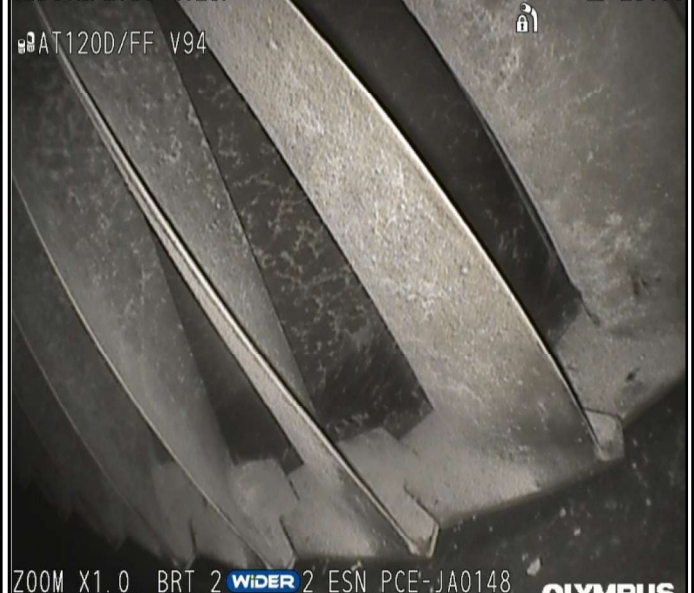
<p>ZOOM X1.0 BRT 2 WIDER 2 ESN PCE-JA0148 2025/08/26 14:32 LPT2 BLADES OLYMPUS</p>
