P&W JT15D-5

AirParts Aero is please to present a pair of JT15D-5 engines removed from a Beechjet 400 which is owned by an AirParts Aero business partner. These engines come from a very well known, vetted source and have been stored and continually maintained during storage. The engines just underwent a thorough boroscope inspection.

ENGINE DISK REPORT							
ESN	PCE-JA-0148	DATE	28-Mar-25	TSN	3062:45		
MSN	RK 190						
POS.	LH	CSN	2433				
Part Description	Part Number	Serial Number	Task	Interval EH	Last Done EH	Next Due EH	Remaining EH
Engine- LH	P& W JT15D-5	PCE-JA0148	HSI	1800:00	1709:15	3509:15	446:30
			Overhaul	3600:00	0:00	3600:00	537:15
Hub Low, Boost Compressor	3038312		Replace	14000:00	00:00	14000:00	10937:15
Disc High Turbine Rotor	3036411		Replace	14000:00	00:00	14000:00	10937:15
Disc Low Turbine Rotor (2nd)	3022212		Replace	14000:00	00:00	14000:00	10937:15
Disc Low Turbine Rotor (3rd)	3041593		Replace	14000:00	00:00	14000:00	10937:15
Hub Low Compressor Rotor	3037911		Replace	12000:00	00:00	12000:00	8937:15
Impeller Centrifugal	3040939		Replace	12000:00	00:00	12000:00	8937:15
Engine Isolator Mount			HSI	1800:00	1709:15	3509:15	446:30

Model : JT15D-5
 A/C MSN : N/A
 ES

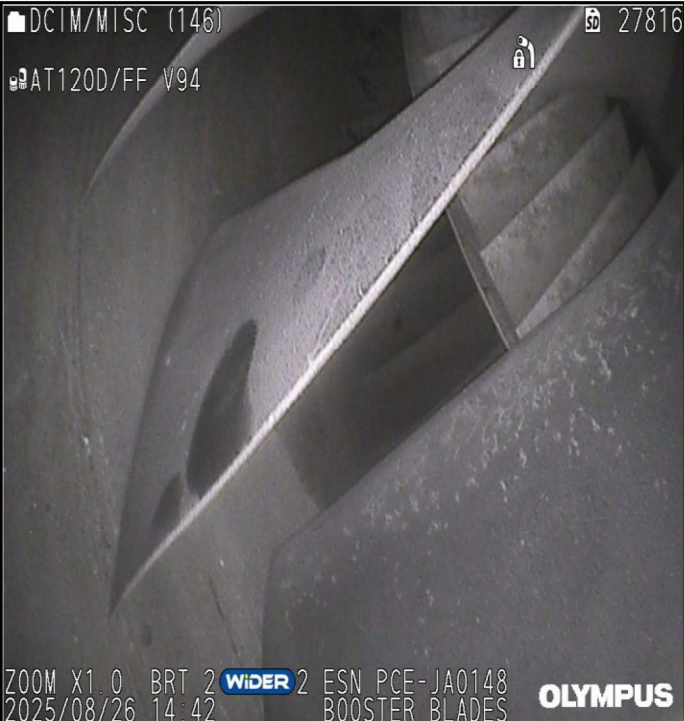
REF AMM 72-00-00	LP BOOSTER BLADES
<p>CONDITION:</p> <p>Contamintion observed with heavy enviromantal deposit.Nil significant findings.</p>

<p>DISPOSITION:</p> <p>Acceptable as per AMM. Serviceable as is.</p>

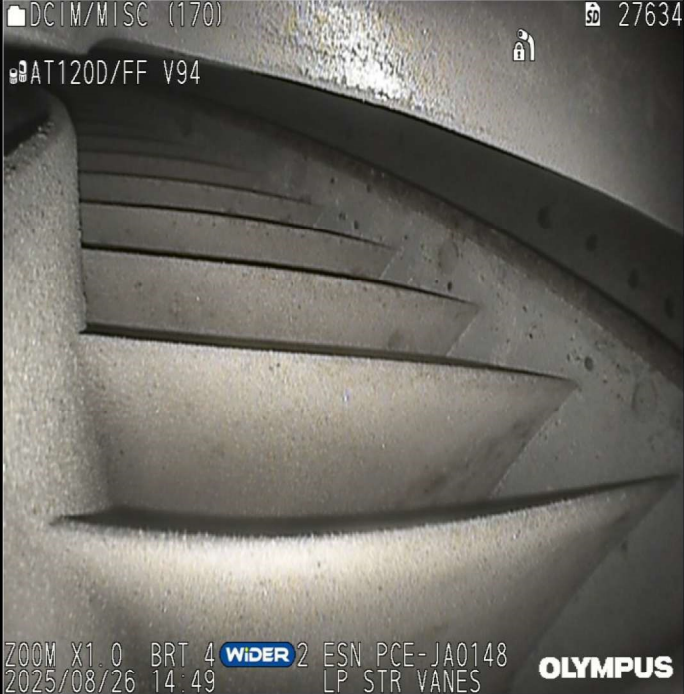
REF AMM 72-00-00	LP STATOR VANES
<p>CONDITION:</p> <p>Contamintion observed with heavy enviromantal deposit.Nil significant findings.</p>

<p>DISPOSITION:</p> <p>Acceptable as per AMM. Serviceable as is.</p>

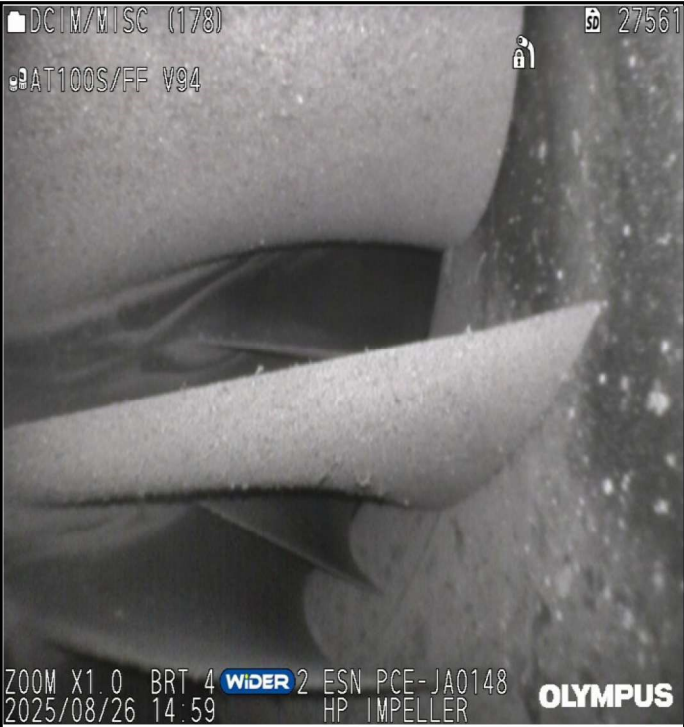
REF AMM 72-00-00	HP IMPELLER
<p>CONDITION:</p> <p>Contamintion observed with heavy enviromantal deposit.Nil significant findings.</p>

<p>DISPOSITION:</p> <p>Acceptable as per AMM. Serviceable as is.</p>

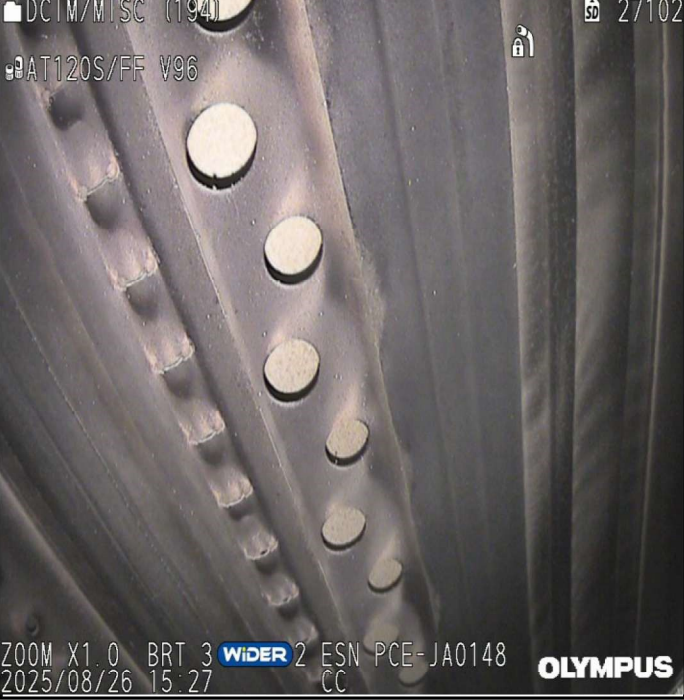
REF AMM 72-00-00	COMBUSTION CHAMBER
<p>CONDITION:</p> <p>Contamintion observed with heavy enviromantal deposit.Nil significant findings.</p>

<p>DISPOSITION:</p> <p>Acceptable as per AMM. Serviceable as is.</p>

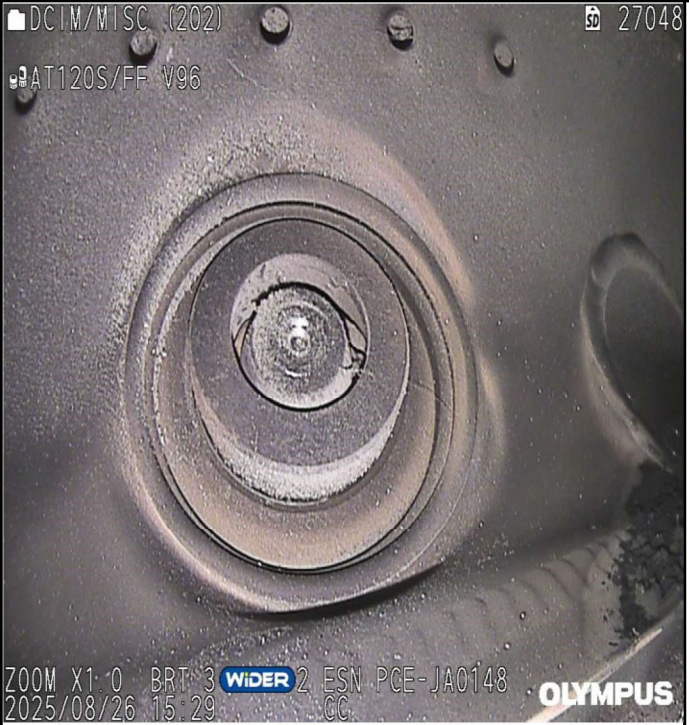
REF AMM 72-00-00	FUEL NOZZLES
<p>CONDITION: Contamintion observed with heavy enviromantal deposit.Nil significant findings.</p>

<p>DISPOSITION: Acceptable as per AMM. Serviceable as is.</p>	
REF AMM 72-00-00	LARGE EXIT DUCT
<p>CONDITION: Contamintion observed with heavy enviromantal deposit.Nil significant findings.</p>

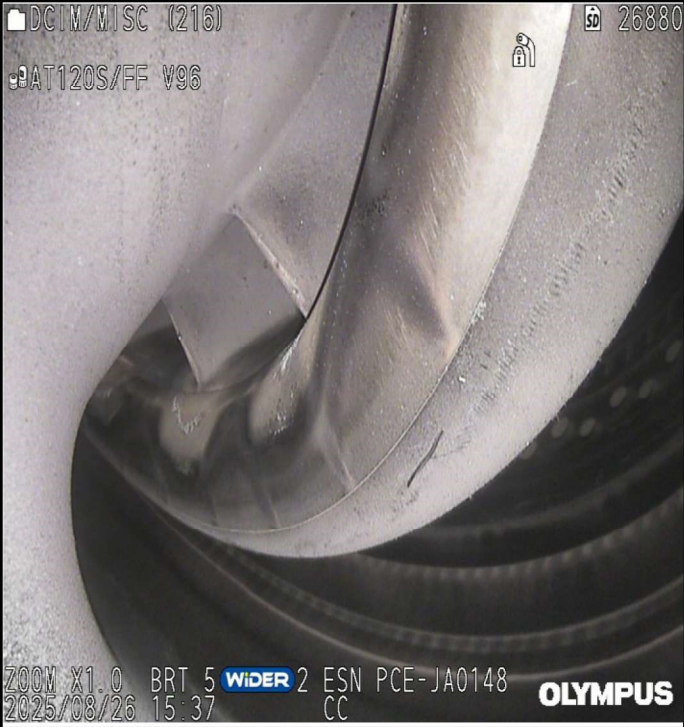
REF AMM 72-00-00	SMALL EXIT DUCT
<p>CONDITION: Contamintion observed with heavy enviromantal deposit.Nil significant findings.</p>

<p>DISPOSITION: Acceptable as per AMM. Serviceable as is.</p>

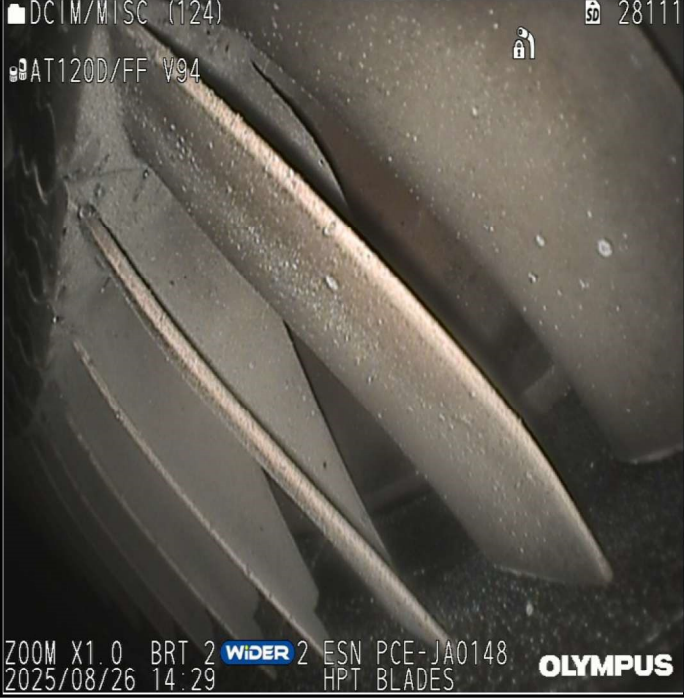
REF AMM 72-00-00	HPT BLADES
<p>CONDITION: Contamintion observed with heavy enviromantal deposit.Nil significant findings.</p>

<p>DISPOSITION: Acceptable as per AMM. Serviceable as is.</p>

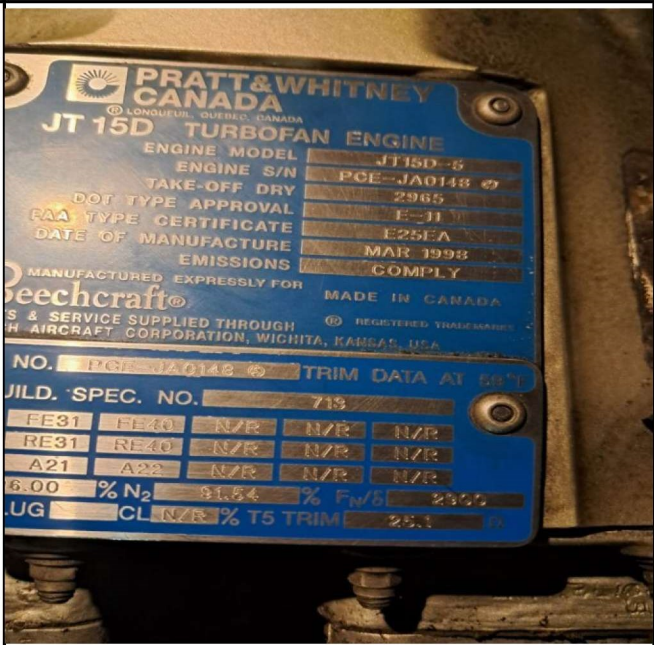
<p>PRATT & WHITNEY CANADA LONGUEUIL, QUEBEC, CANADA JT15D TURBOFAN ENGINE ENGINE MODEL JT15D-6 ENGINE S/N PCE-JA0148 TAKE-OFF DRY 2985 DOT TYPE APPROVAL E-11 FAA TYPE CERTIFICATE E25EA DATE OF MANUFACTURE MAR 1998 EMISSIONS COMPLY MANUFACTURED EXPRESSLY FOR Peechcraft® MADE IN CANADA PARTS & SERVICE SUPPLIED THROUGH HAWK AIRCRAFT CORPORATION, WICHITA, KANSAS, USA NO. PCE-JA0148 TRIM DATA AT 50% JILD. SPEC. NO. 719 FE31 FE40 N/R N/R N/R RE31 RE40 N/R N/R N/R A21 A22 N/R N/R N/R 6.00 % N₂ 91.54 % F_w/5 2307 UG CL N/R % T5 TRIM 28.1</p>

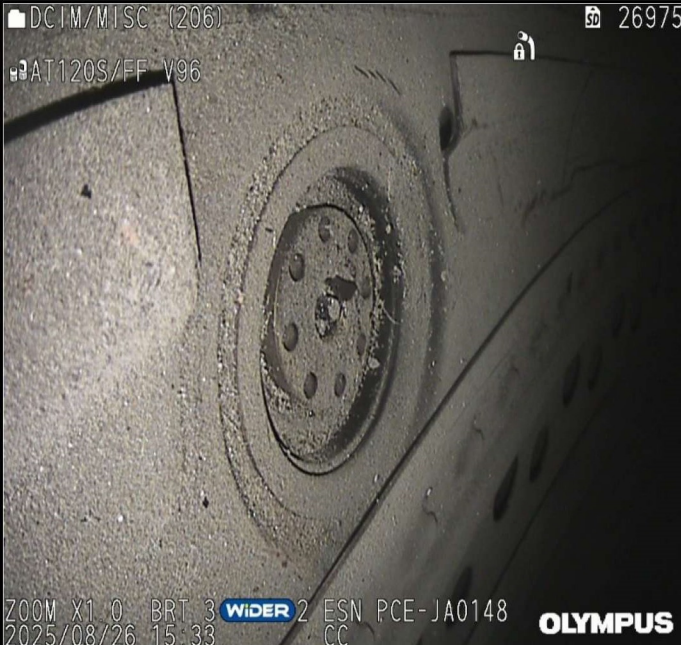
<p>DCIM/MISC (206) 26975 AT120S/FF V96 ZOOM X1.0 BRT 3 WIDER 2 ESN PCE-JA0148 2025/08/26 15:33 CC OLYMPUS</p>

Engine internal hardware condition is satisfactory as per AMM. Engine water wash is recommended.

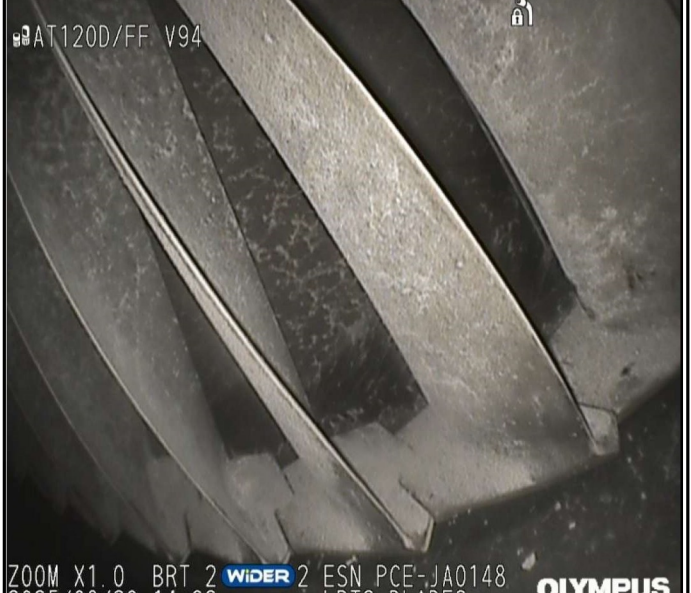
<p>ZOOM X1.0 BRT 2 WIDER 2 ESN PCE-JA0148 2025/08/26 14:32 LPT2 BLADES OLYMPUS</p>

REF AMM 72-00-00	LPT STAGE 2 BLADES
<p>CONDITION: Contamination observed with heavy enviromantal deposit.Nil significant findings.</p>	 
<p>DISPOSITION: Acceptable as per AMM. Serviceable as is.</p>
