A/C Type : N/A  
 A/C Registration : N/A  
 Reason for BSI :Assessment

Model : JT15D-5  
 A/C MSN : N/A  
 ESN : PCE-JA0147  
 TSN:3062:45

VIDEO BOROSCOPE INSPECTION OF ENGINE JT15D-5 REPORT

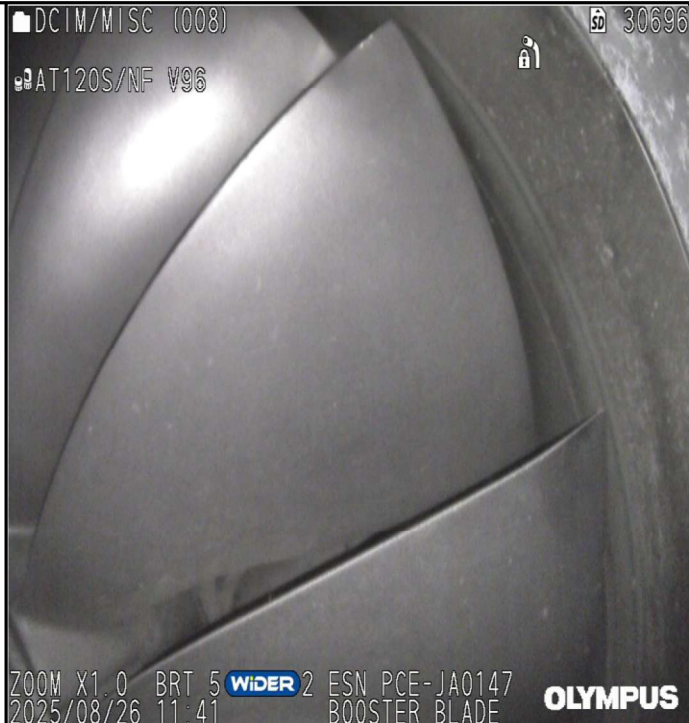
REF AMM 72-00-00	LP BOOSTER BLADES
<p><b>CONDITION:</b>                  Contamination observed with heavy enviromantal deposit.Nil significant findings.</p>

<p><b>DISPOSITION:</b>                  Acceptable as per AMM.                  Serviceable as is.</p>

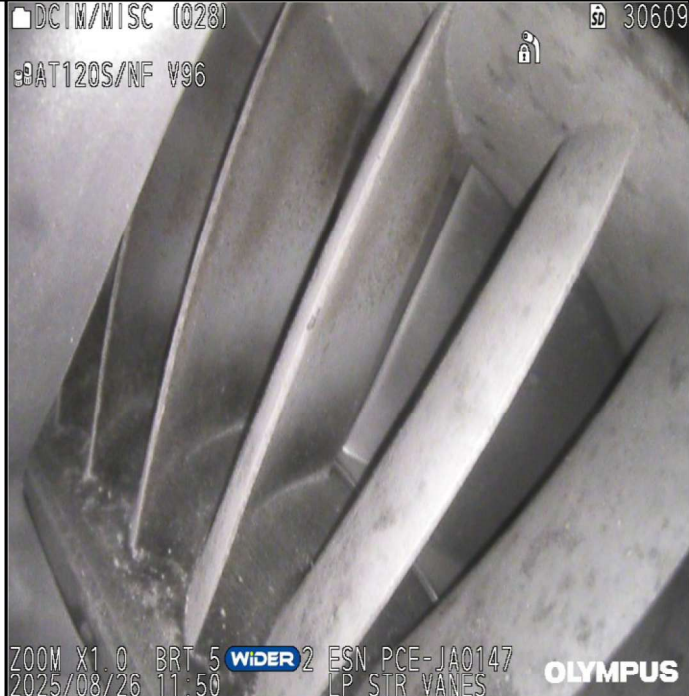
REF AMM 72-00-00	LP STATOR VANES
<p><b>CONDITION:</b>                  Contamination observed with heavy enviromantal deposit.Nil significant findings.</p>

<p><b>DISPOSITION:</b>                  Acceptable as per AMM.                  Serviceable as is.</p>

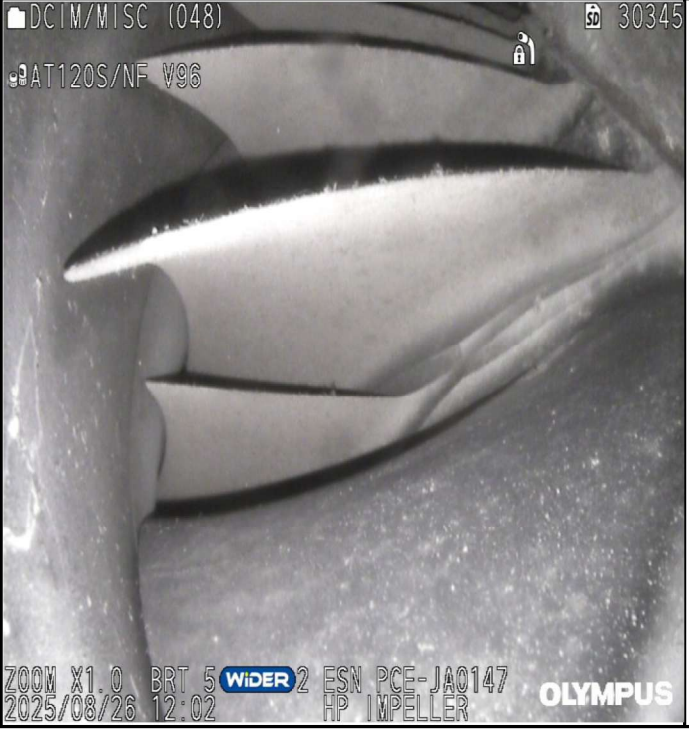
REF AMM 72-00-00	HP IMPELLER
<p><b>CONDITION:</b>                      Contamination observed with heavy enviromantal deposit.Nil significant findings.</p>

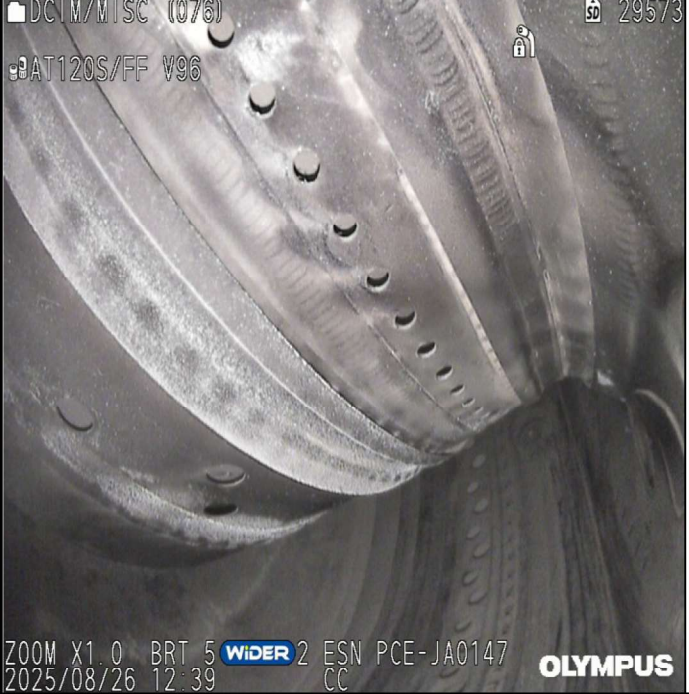
<p><b>DISPOSITION:</b>                      Acceptable as per AMM.                      Serviceable as is.</p>	
REF AMM 72-00-00	COMBUSTION CHAMBER
<p><b>CONDITION:</b>                      Contamination observed with heavy enviromantal deposit.Nil significant findings.</p>

<p><b>DISPOSITION:</b>                      Acceptable as per AMM.                      Serviceable as is.</p>

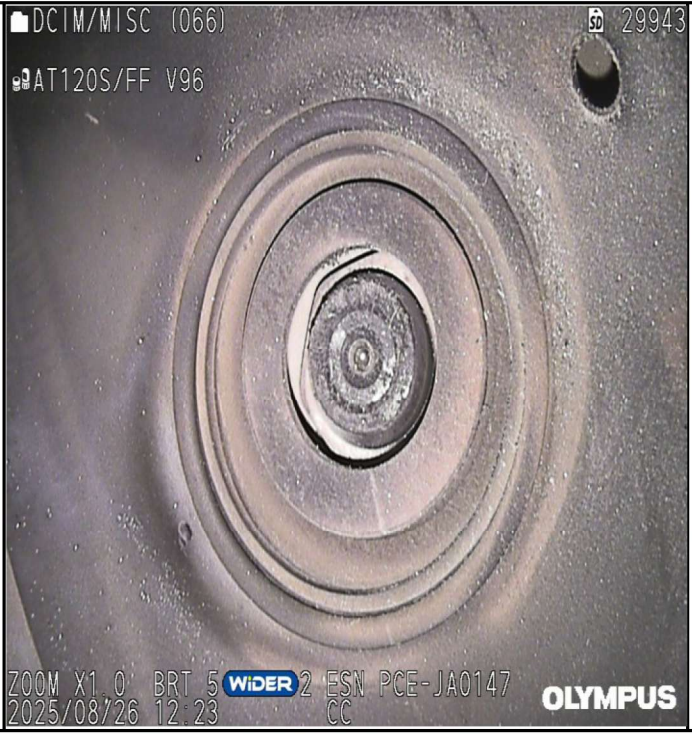
REF AMM 72-00-00	FUEL NOZZLES
<p><b>CONDITION:</b>                      Contamination observed with heavy enviromantal deposit.Nil significant findings.</p>

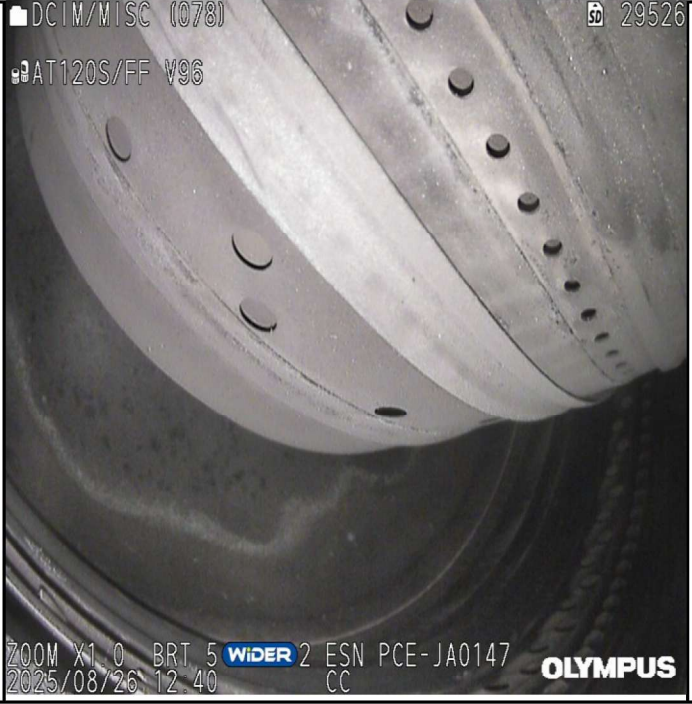
<p><b>DISPOSITION:</b>                      Contamination observed with heavy enviromantal deposit.Nil significant findings.</p>	
REF AMM 72-00-00	LARGE EXIT DUCT
<p><b>CONDITION:</b>                      Contamination observed with heavy enviromantal deposit.Nil significant findings.</p>

<p><b>DISPOSITION:</b>                      Acceptable as per AMM.                      Serviceable as is.</p>

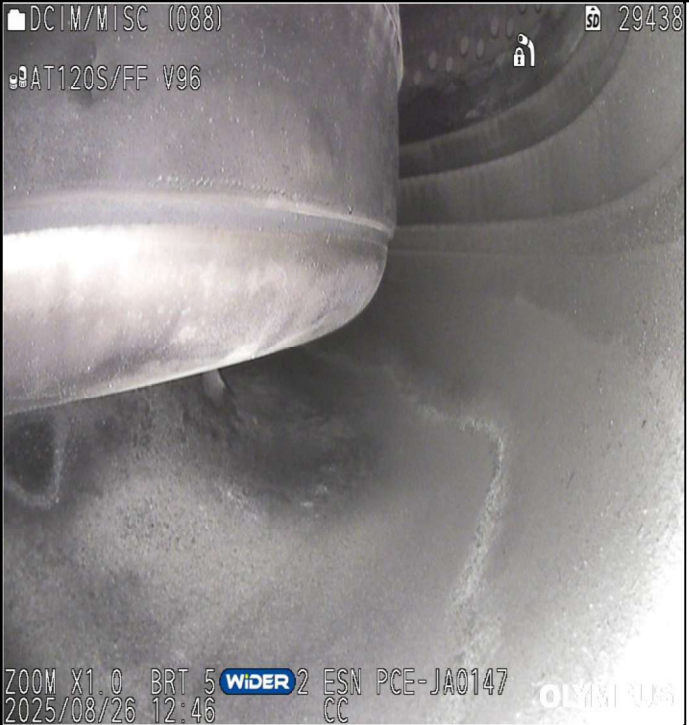
REF AMM 72-00-00	SMALL EXIT DUCT
<p><b>CONDITION:</b>            Contamination observed with heavy enviromantal deposit.Nil significant findings.</p>

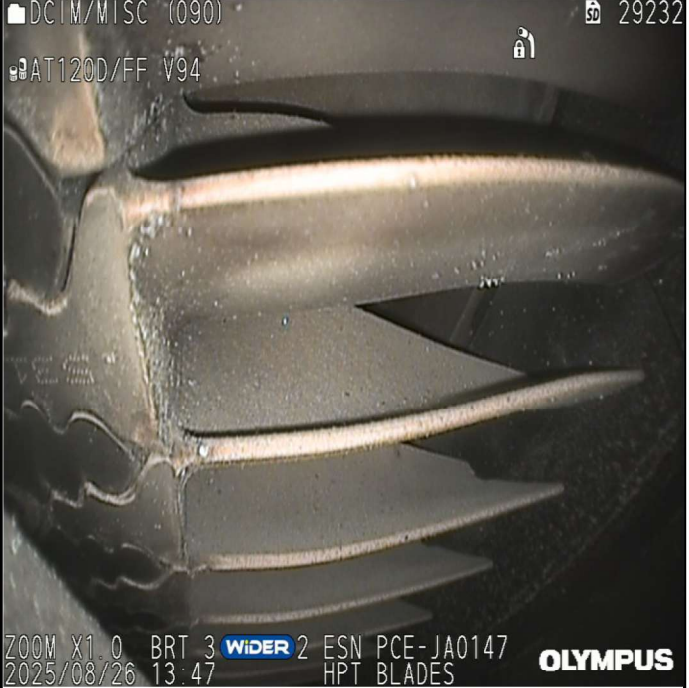
<p><b>DISPOSITION:</b>            Acceptable as per AMM.            Serviceable as is.</p>	
REF AMM 72-00-00	HPT BLADES
<p><b>CONDITION:</b>            Observed nonmeasurable dent on trailing edge ,towards tip area of QTY-02 blades. Also contamination observed with heavy enviromantal deposit, through out the stage, Nil significant findings.</p>

<p><b>DISPOSITION:</b>            Acceptable as per AMM.            Serviceable as is.</p>

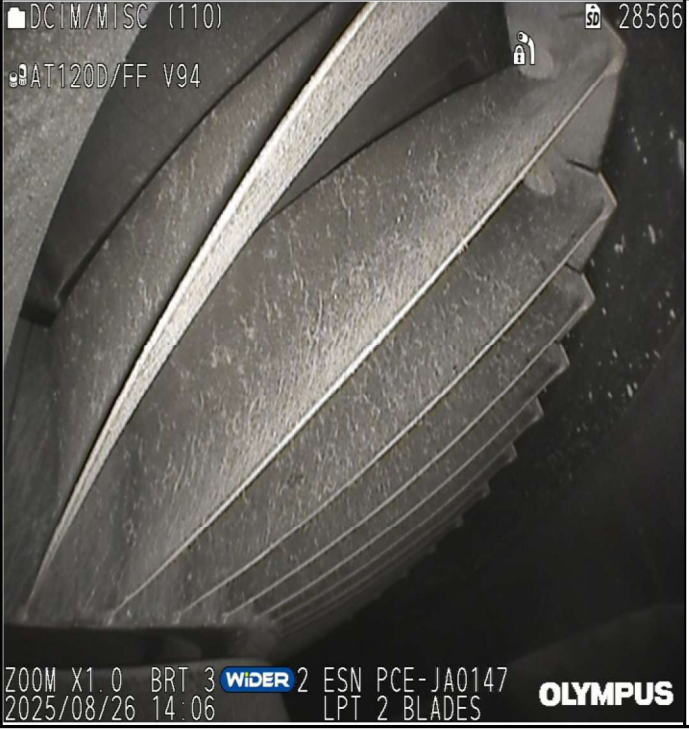
REF AMM 72-00-00	LPT STAGE 2 BLADES
<p><b>CONDITION:</b>                      Contamination observed with heavy enviromantal deposit.Nil significant findings.</p>

<p><b>DISPOSITION:</b>                      Acceptable as per AMM.                      Serviceable as is.</p>
