# P&W JT15D-5

Engine Part number	Engine Serial Number	TSN	CSN
P&W JT15D-5	PCE-JA-0147	3062:45	2433

AirParts Aero is please to present a pair of JT15D-5 engines removed from a Beechjet 400 which is owned by an AirParts Aero business partner. These engines come from a very well known, vetted source and have been stored and continually maintained during storage. The engines just underwent a thorough boroscope inspection.

VIDEO BOROSCOPE INSPECTION OF ENGINE JT15D-5 REPORT

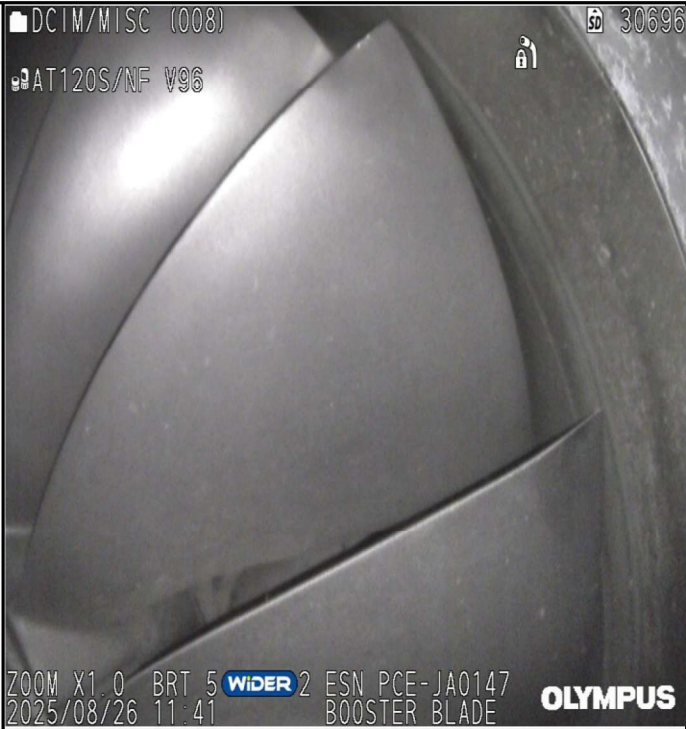
REF AMM 72-00-00	LP BOOSTER BLADES
<p><b>CONDITION:</b>            Contamination observed with heavy enviromantal deposit.Nil significant findings.</p>

<p><b>DISPOSITION:</b>            Acceptable as per AMM.            Serviceable as is.</p>

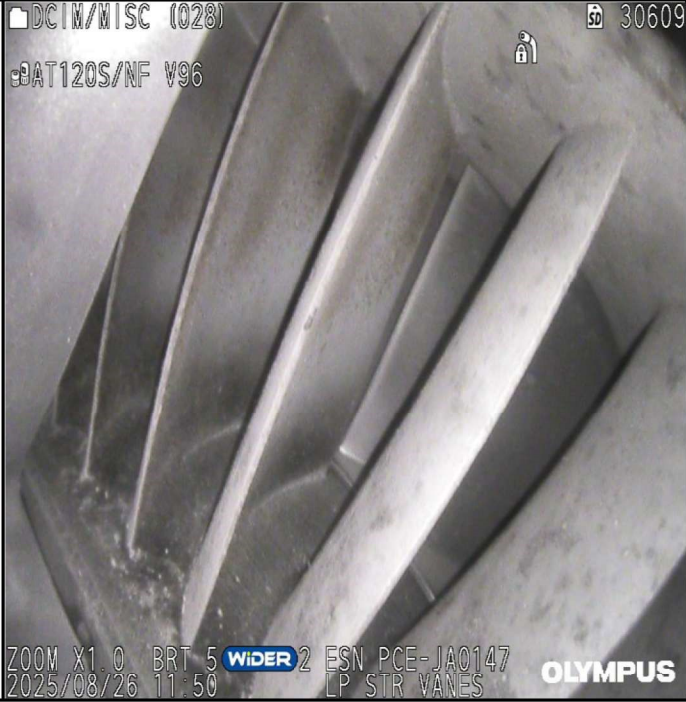
REF AMM 72-00-00	LP STATOR VANES
<p><b>CONDITION:</b>            Contamination observed with heavy enviromantal deposit.Nil significant findings.</p>

<p><b>DISPOSITION:</b>            Acceptable as per AMM.            Serviceable as is.</p>

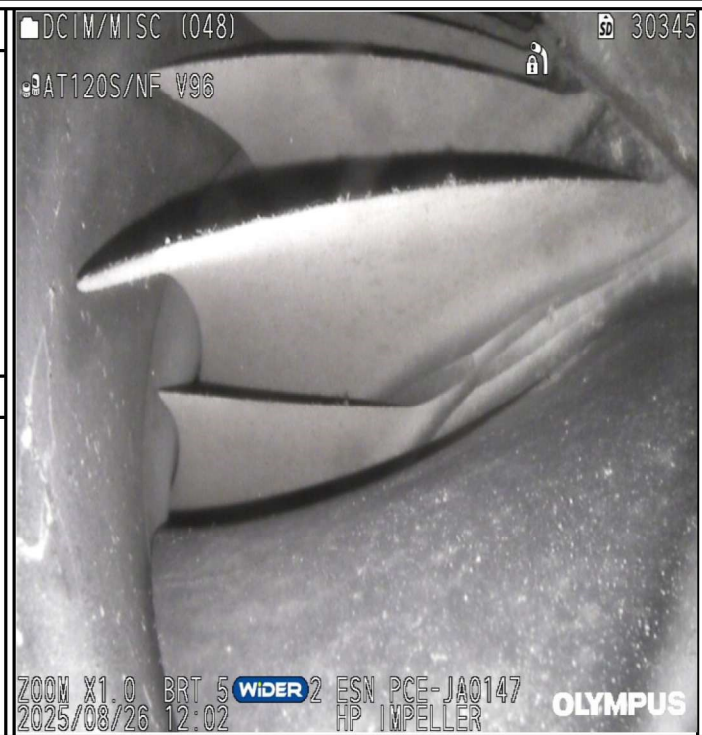
REF AMM 72-00-00	HP IMPELLER
------------------	-------------

**CONDITION:**  
 Contamination observed with heavy enviromantal deposit.Nil significant findings.

**DISPOSITION:**  
 Acceptable as per AMM.  
 Serviceable as is.

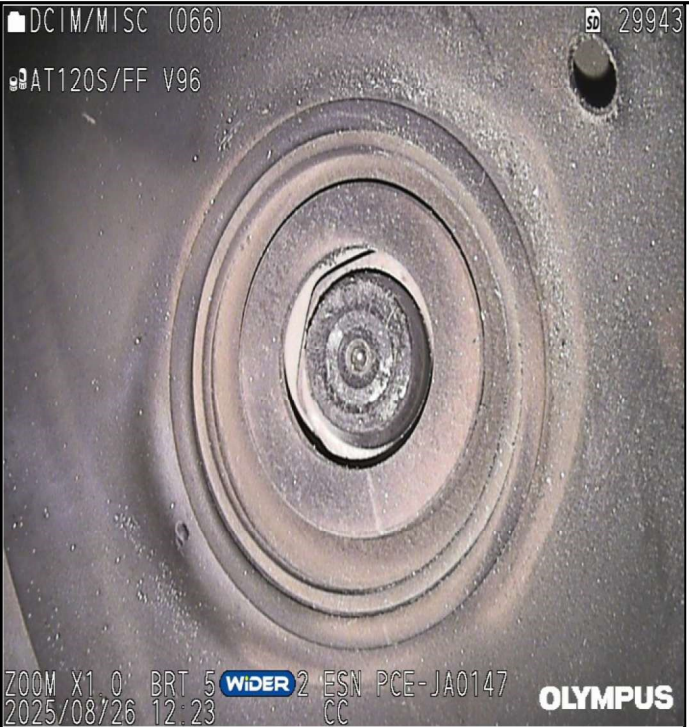
REF AMM 72-00-00	FUEL NOZZLES
<p><b>CONDITION:</b>                      Contamination observed with heavy enviromantal deposit.Nil significant findings.</p>

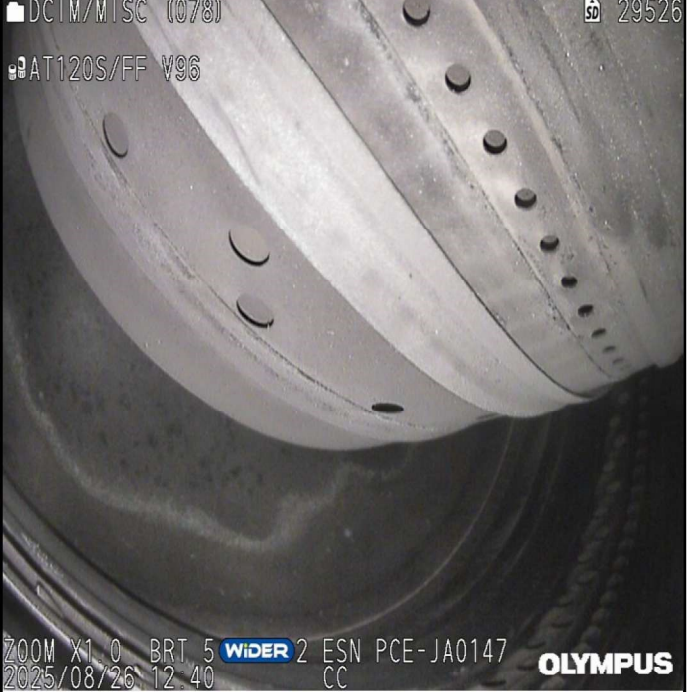
<p><b>DISPOSITION:</b>                      Contamination observed with heavy enviromantal deposit.Nil significant findings.</p>	
REF AMM 72-00-00	LARGE EXIT DUCT
<p><b>CONDITION:</b>                      Contamination observed with heavy enviromantal deposit.Nil significant findings.</p>

<p><b>DISPOSITION:</b>                      Acceptable as per AMM.                      Serviceable as is.</p>

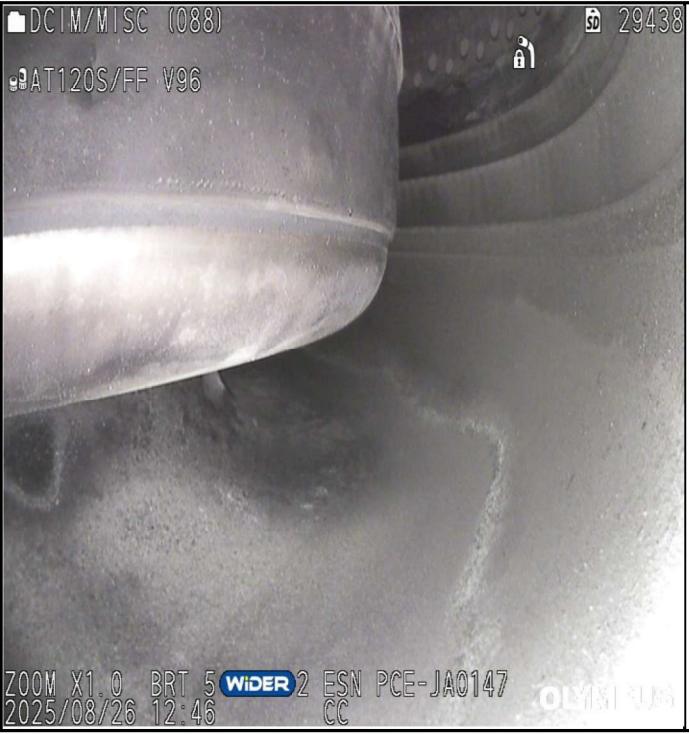
REF AMM 72-00-00	SMALL EXIT DUCT
<p><b>CONDITION:</b>            Contamination observed with heavy enviromantal deposit.Nil significant findings.</p>

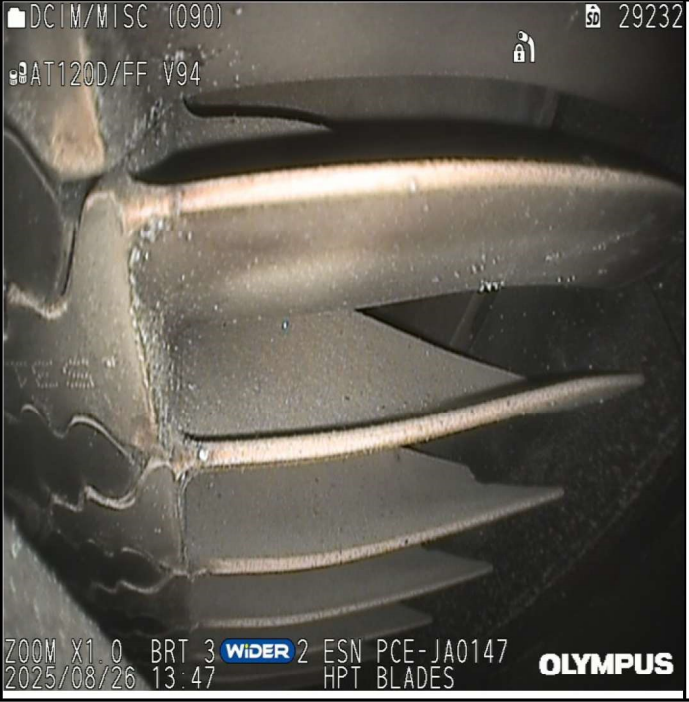
<p><b>DISPOSITION:</b>            Acceptable as per AMM.            Serviceable as is.</p>	
REF AMM 72-00-00	HPT BLADES
<p><b>CONDITION:</b>            Observed nonmeasurable dent on trailing edge ,towards tip area of QTY-02 blades. Also contamination observed with heavy enviromantal deposit, through out the stage, Nil significant findings.</p>

<p><b>DISPOSITION:</b>            Acceptable as per AMM.            Serviceable as is.</p>

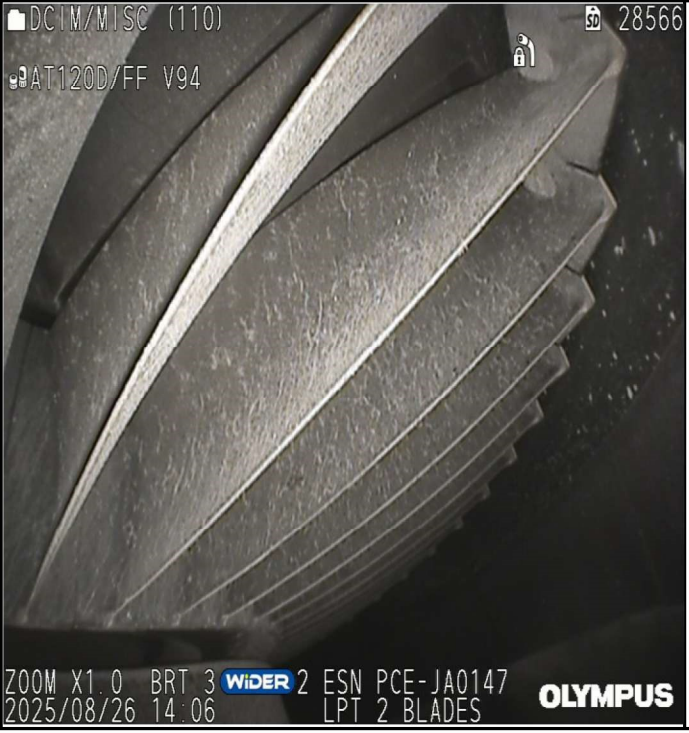
REF AMM 72-00-00	LPT STAGE 2 BLADES
<p><b>CONDITION:</b>                      Contamination observed with heavy enviromantal deposit.Nil significant findings.</p>

<p><b>DISPOSITION:</b>                      Acceptable as per AMM.                      Serviceable as is.</p>

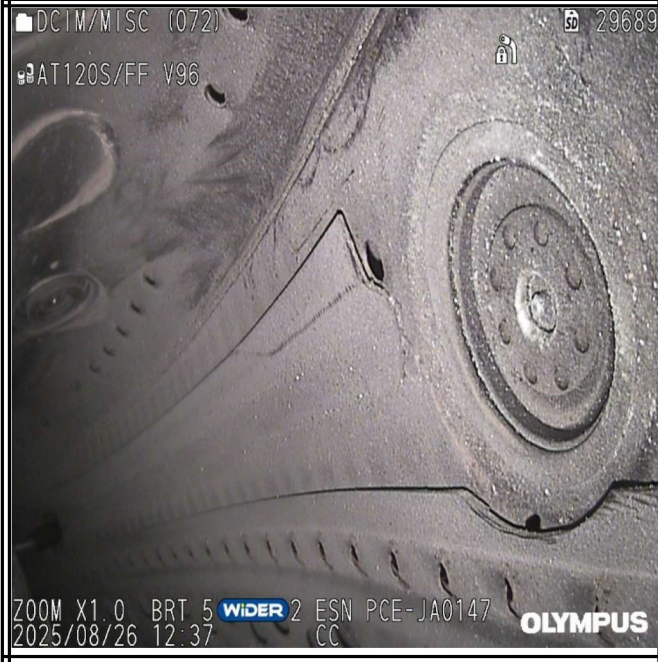
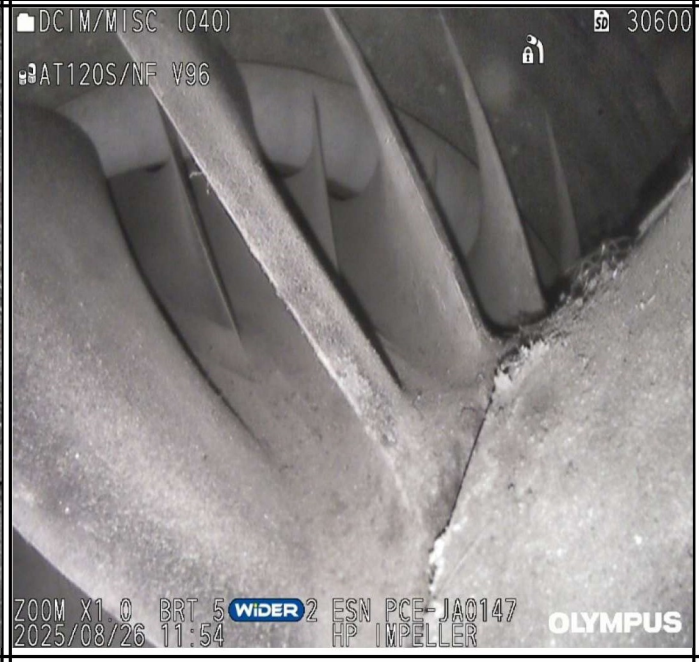
ADDITIONAL COMMENTS AND PICTURES:	
  <p>DCIM/MISC (096) 28981 AT120D/FF V94 ZOOM X1.0 BRT 1 WIDER 2 ESN PCE-JA0147 2025/08/26 13:54 HPT BLADES OLYMPUS</p>	  <p>DCIM/MISC (008) 30696 AT120S/NF V96 ZOOM X1.0 BRT 5 WIDER 2 ESN PCE-JA0147 2025/08/26 11:41 BOOSTER BLADE OLYMPUS</p>
  <p>DCIM/MISC (084) 29462 AT120S/FF V96 ZOOM X1.0 BRT 5 WIDER 2 ESN PCE-JA0147 2025/08/26 12:42 CC OLYMPUS</p>	  <p>DCIM/MISC (028) 30609 AT120S/NF V96 ZOOM X1.0 BRT 5 WIDER 2 ESN PCE-JA0147 2025/08/26 11:50 LP STR VANES OLYMPUS</p>

**Engine internal hardware condition is satisfactory as per AMM. Engine water wash is recommended.**
